INVESTIGATION OF DIAGONAL-TENSION BEAMS WITH VERY THIN STIFFENED WEBS.

Alexander G. Tsongas and Robert T. Ratay

Structural Mechanics Section
GRUMMAN AEROSPACE CORPORATION
BETHPAGE, NEW YORK 11714

July 1969

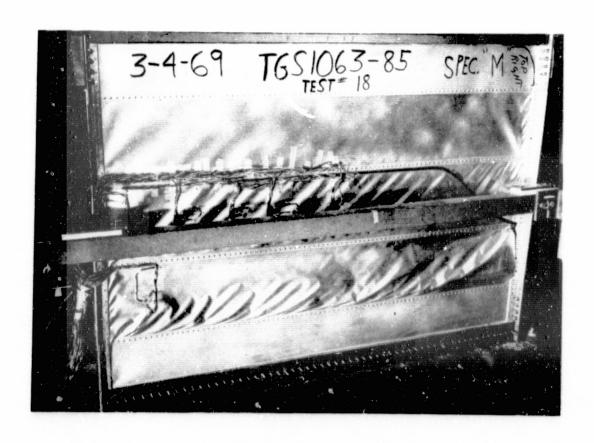
Photo 15. Panel M after Collapse

There is indication, based on sounds of rivet "popping" and a visible flying rivet on the high-speed movie, that the failure of Panel M was precipitated by premature rivet failure.

Test #18, Panel M. Stiffener-to-flange rivets failed at right end of Stiffener #3; web failed in tension at left end of Bay #2.
